# Structural integrity of the graphite cores in the UK AGR: A focus on life-extension

T.J. Marrow  
Department of Materials & Oxford Martin School, University of Oxford

*Cambridge—January 2013*

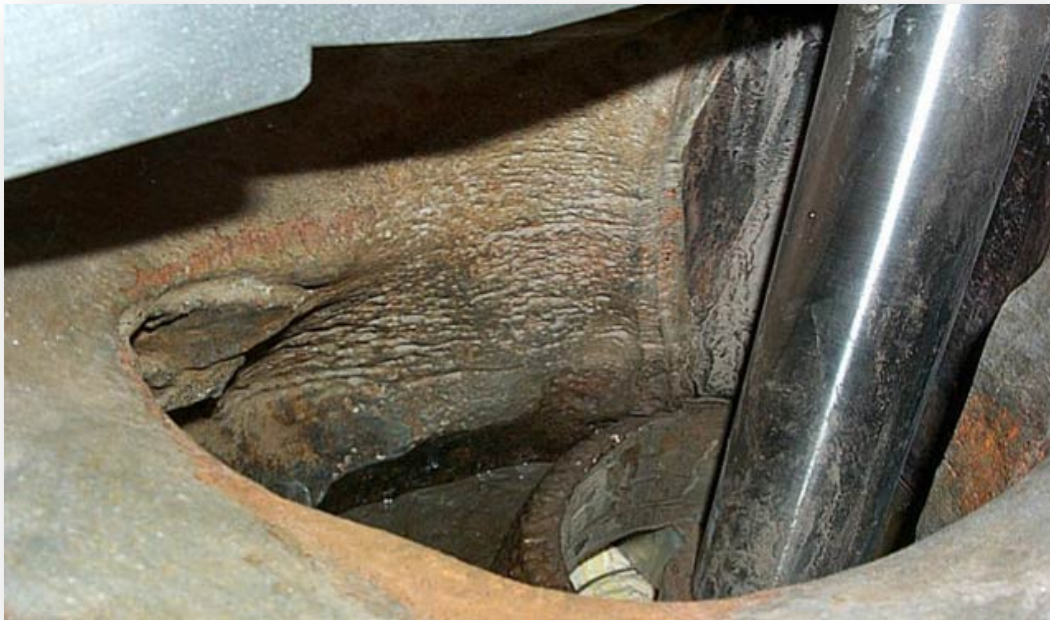
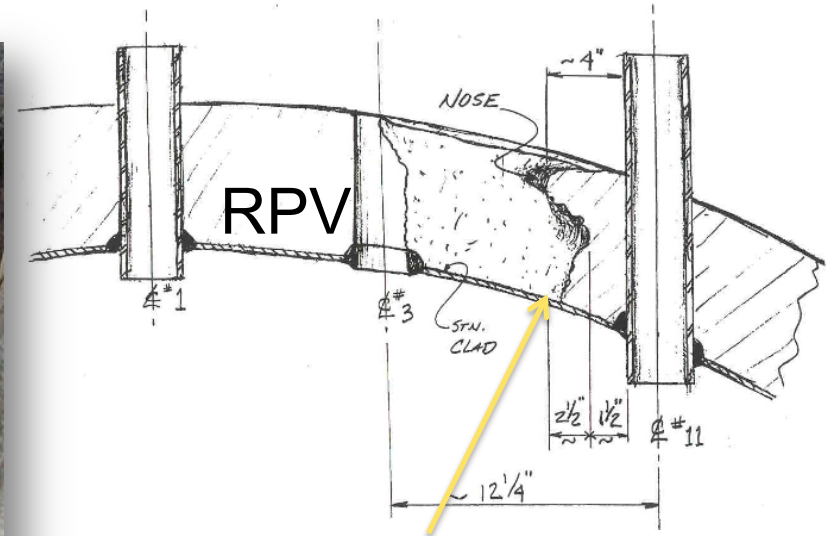
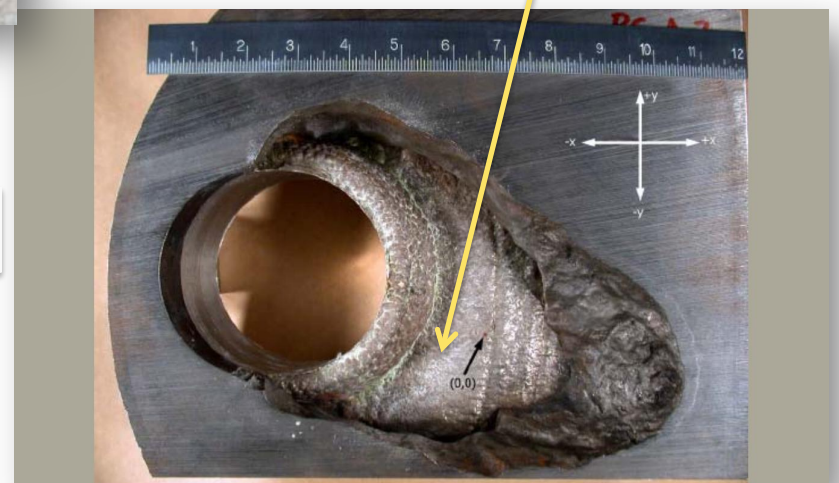
Cladding (stainless steel)

This is an unusual degree of corrosion

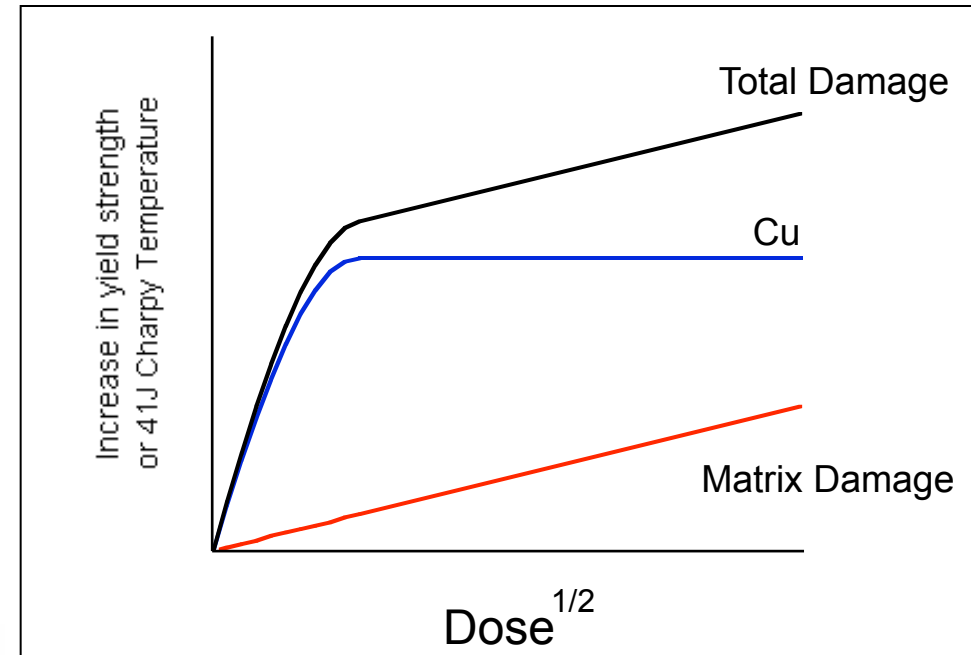
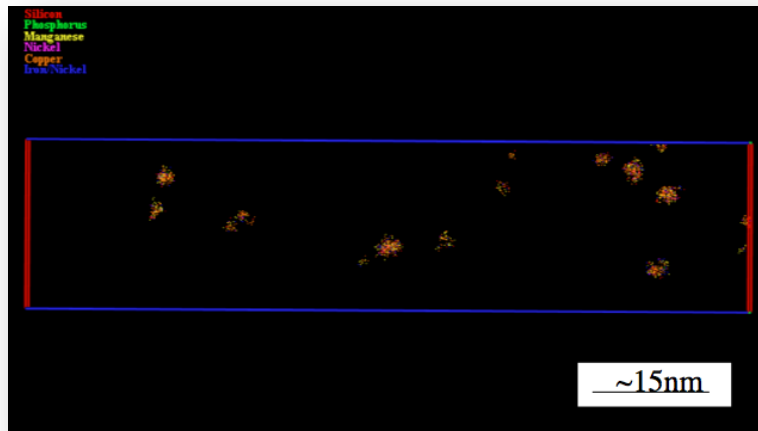
Atom probe images of Cu clusters

Cu, Mn, Ni, Si, P, Fe

Hardening causes embrittlement

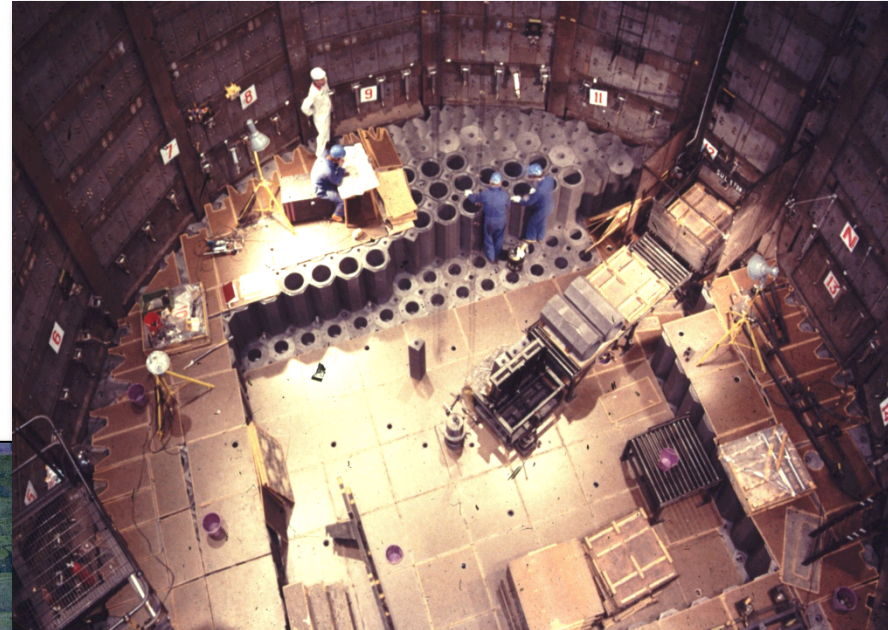
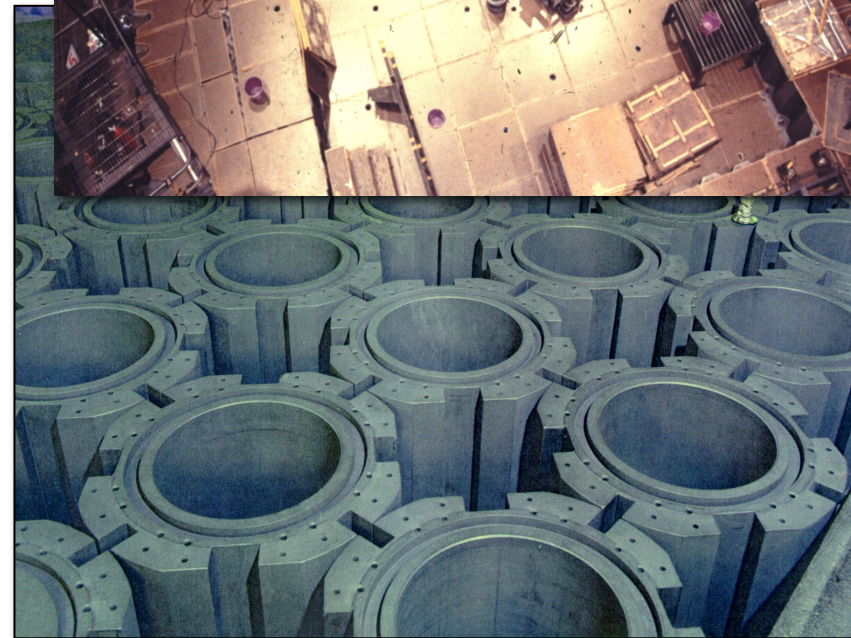
Heysham 2/Torness (during construction)

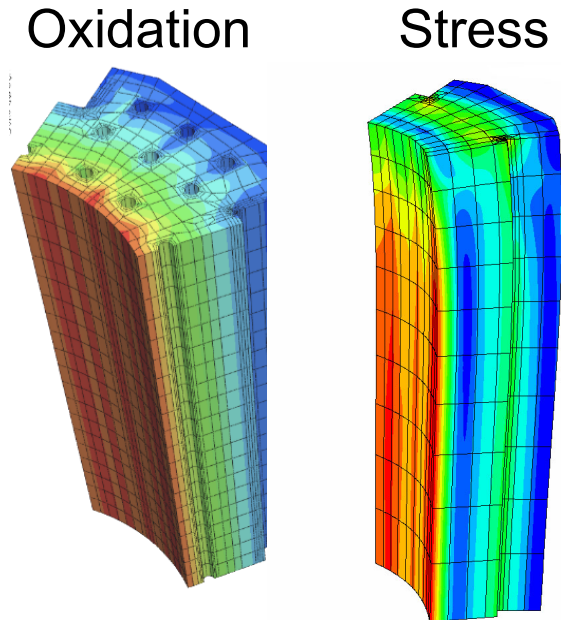
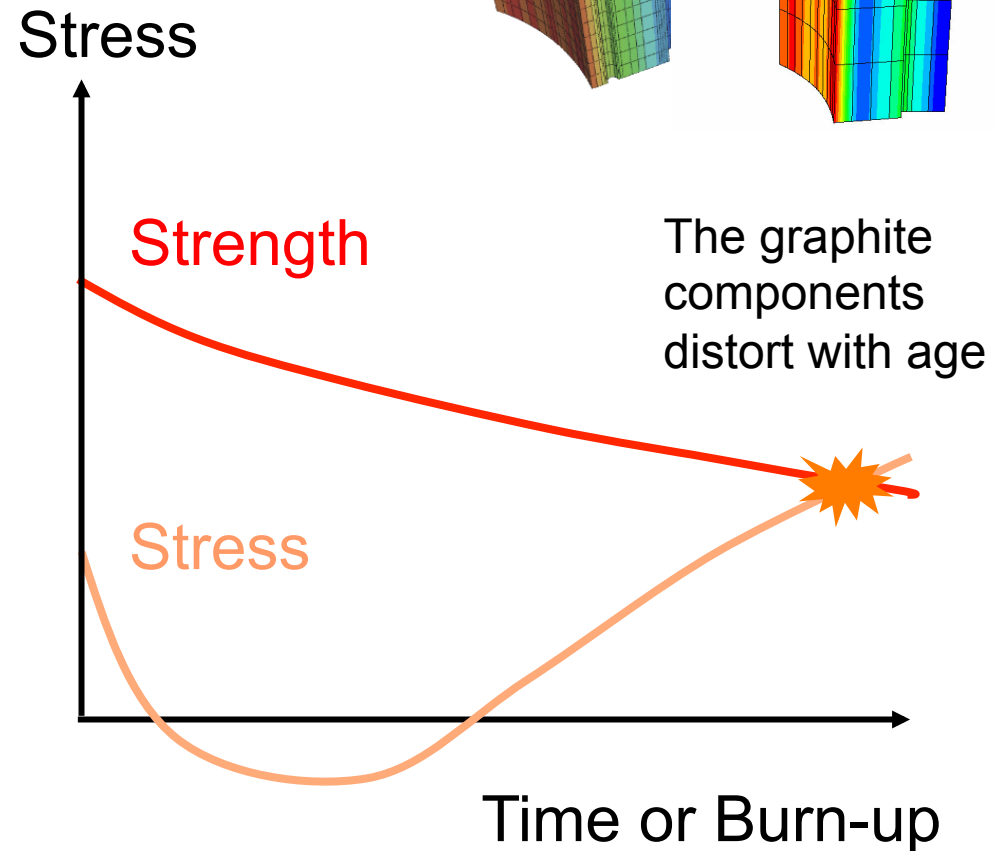
- Stress can become tensile with irradiation at some positions in the brick
- Strength reduces with radiolytic oxidation
- A simple crack initiation criterion is currently assumed: failure predicted when stress exceeds tensile strength
- Models can predict distributions of properties

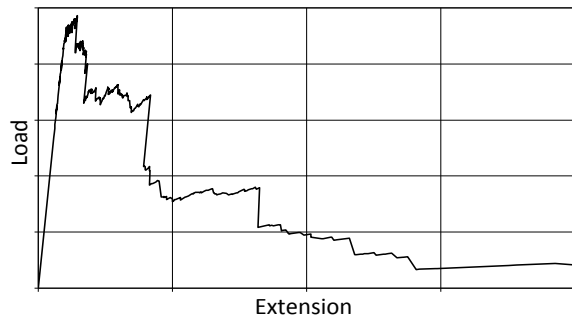
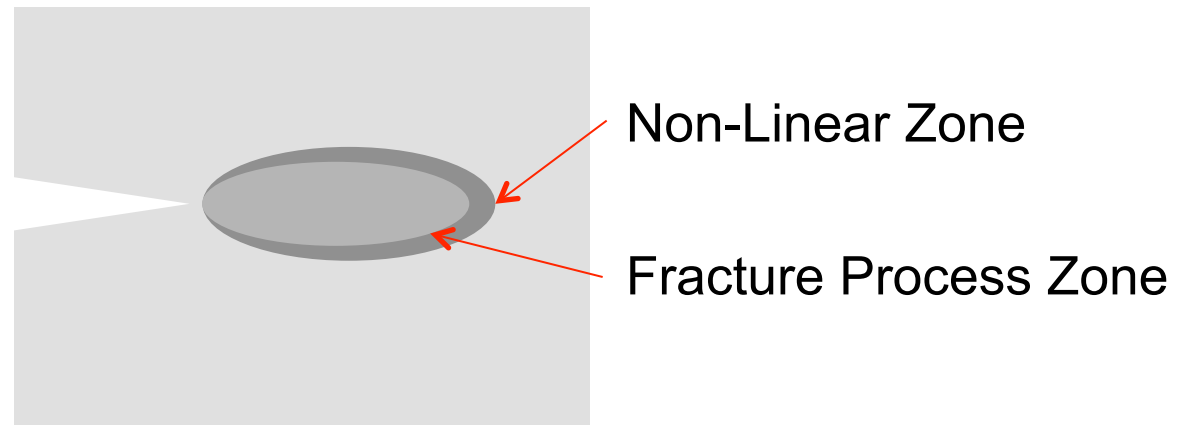
"Graceful" failure of a quasi-brittle material

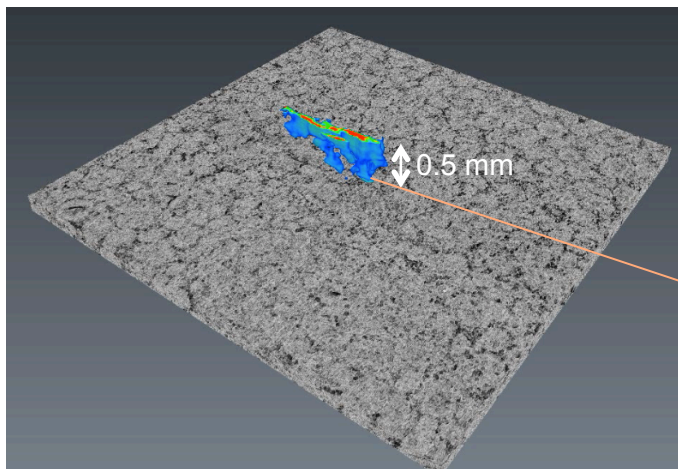
*Crack nucleus revealed by digital volume correlation of computed X-ray tomography data (in-situ loading)*

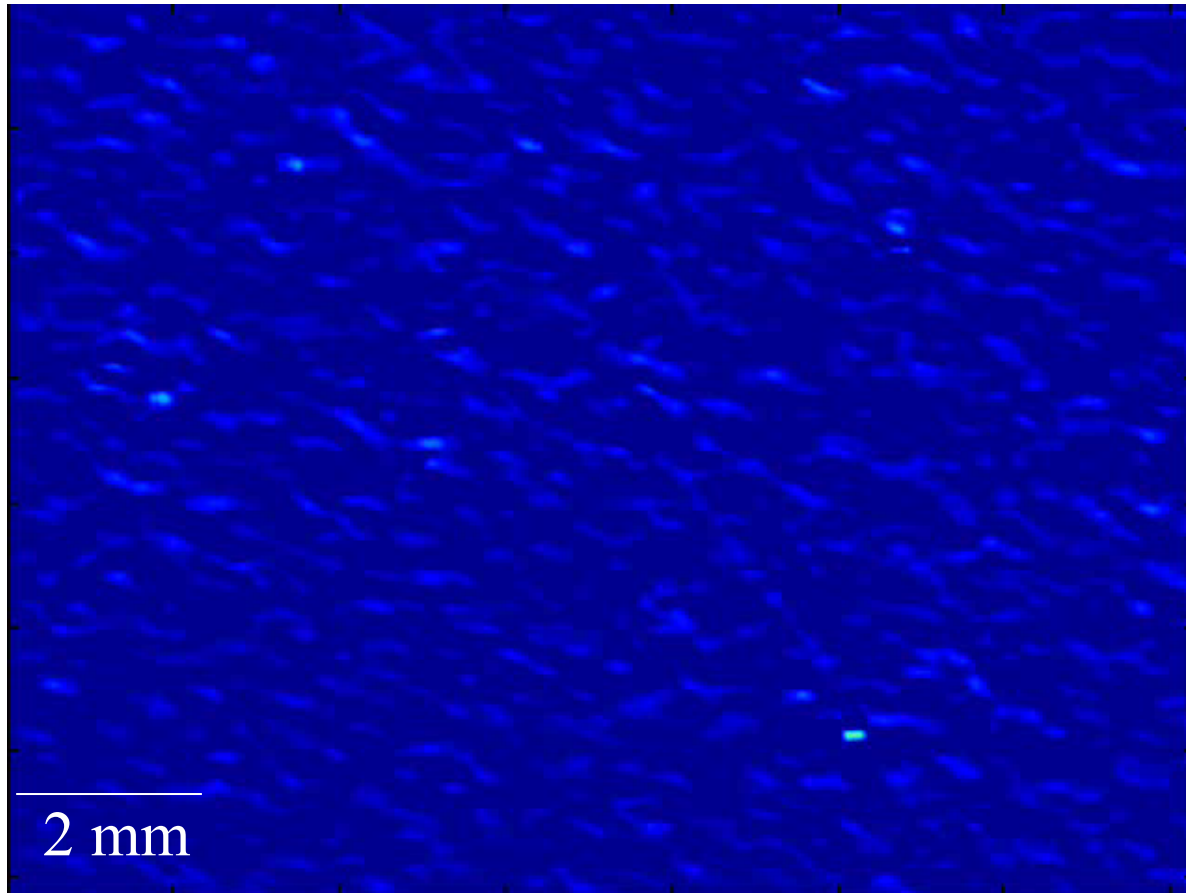
Gilsocarbon Graphite

Tensile Loading

- Failure of the sample is preceded by propagation of a crack nucleus by the successive formation and coalescence of micro-cracks. These tend to be associated with significant porosity
- Final failure in small test specimens may depend on the development of instability in a single, stably propagating defect.

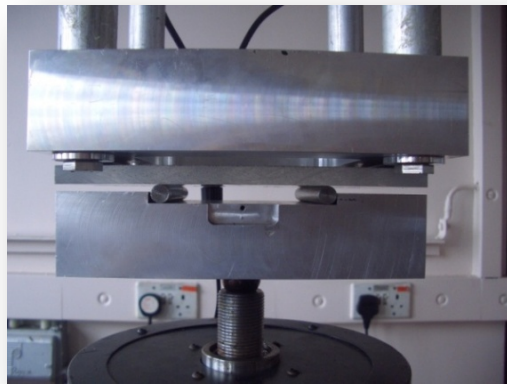
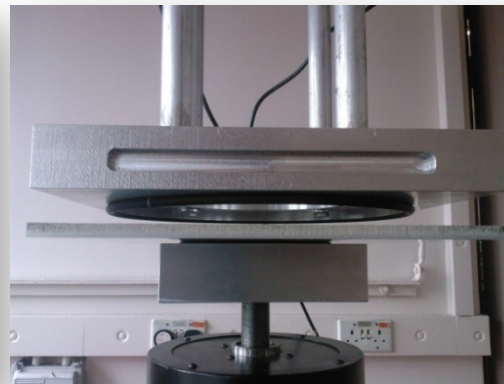
Uniaxial

Equi-biaxial

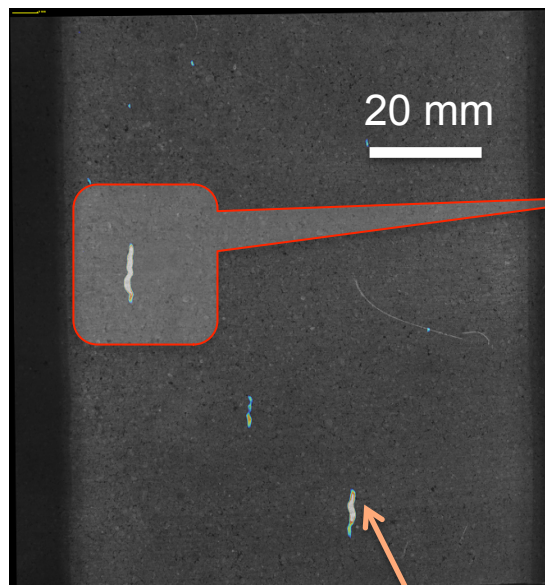
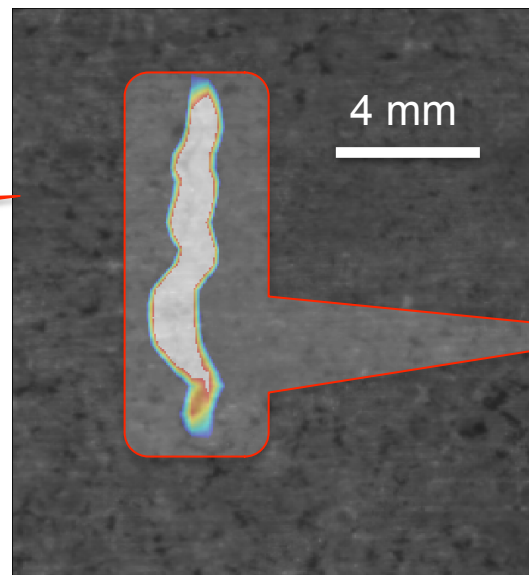
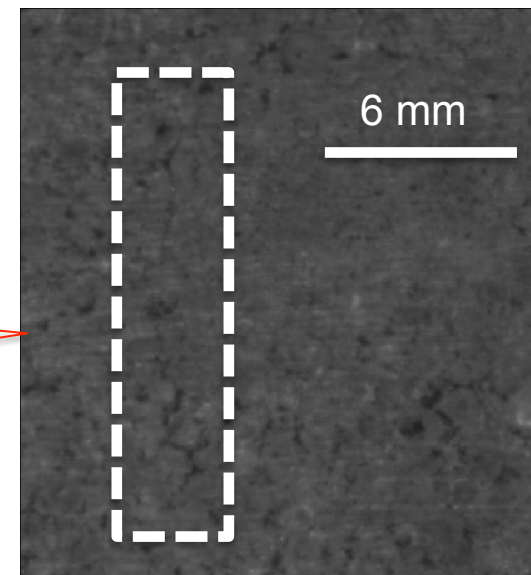
- Cracks *just* visible under load
- Digital Image Correlation reveals the crack

Failure Initiator

A 50mm lens was used to capture the whole surface of the sample, so enlarged images of small areas are blurred

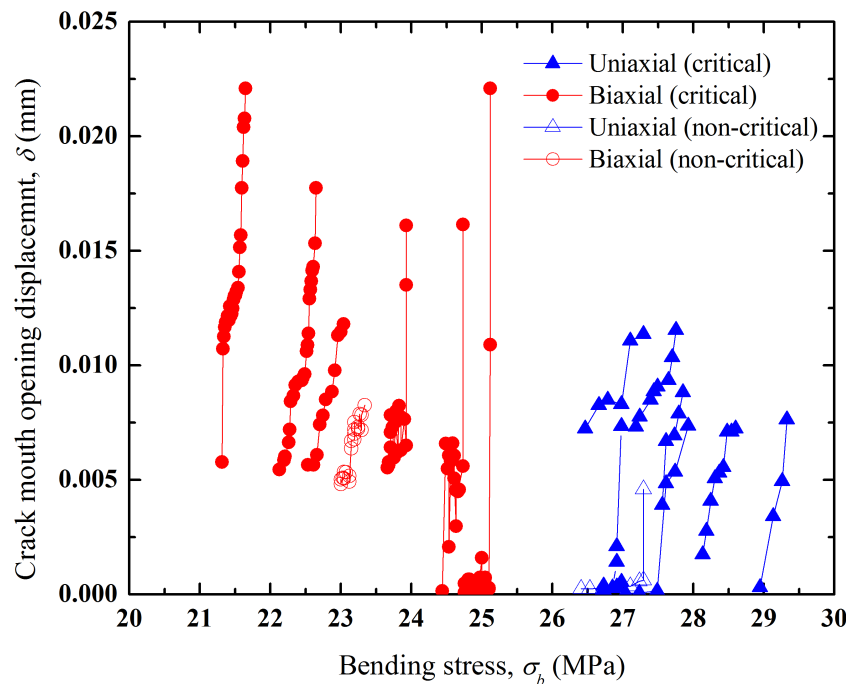
- Crack depth may be estimated from the elastic crack opening
- Defects open more under biaxial load than under uniaxial load

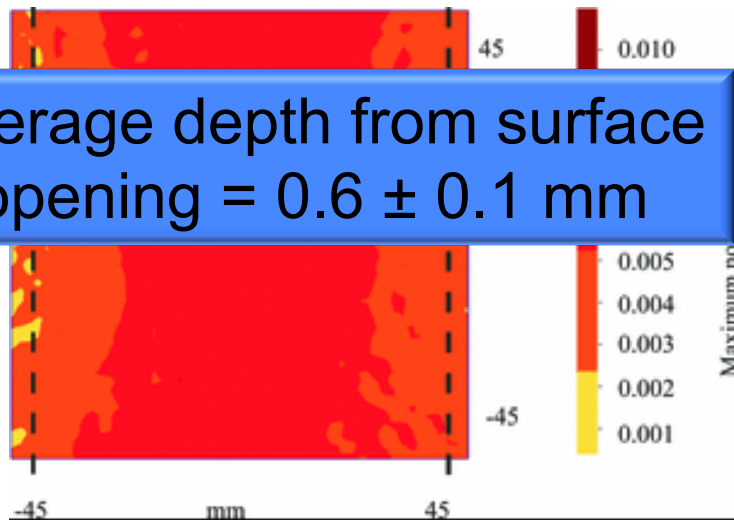
Average depth from surface opening =  $0.6 \pm 0.1$  mm

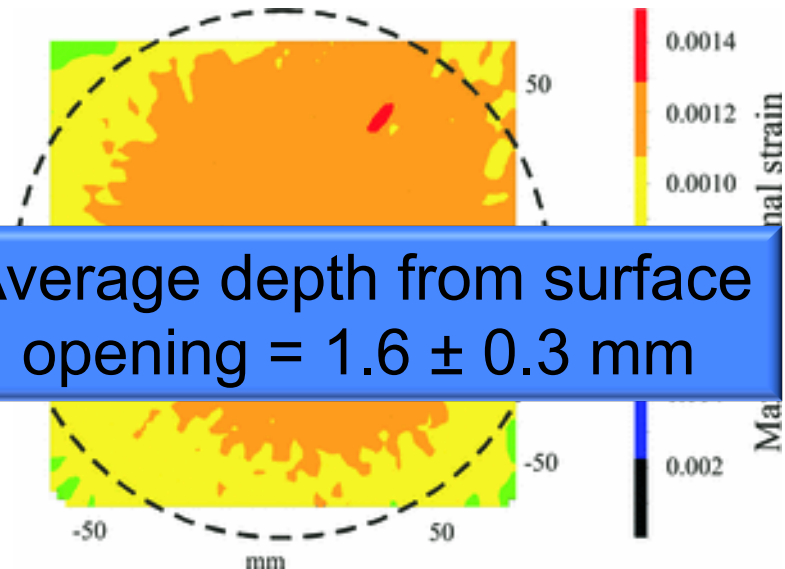
This can't be right, as it's the same microstructure...

Average depth from surface opening =  $1.6 \pm 0.3$  mm

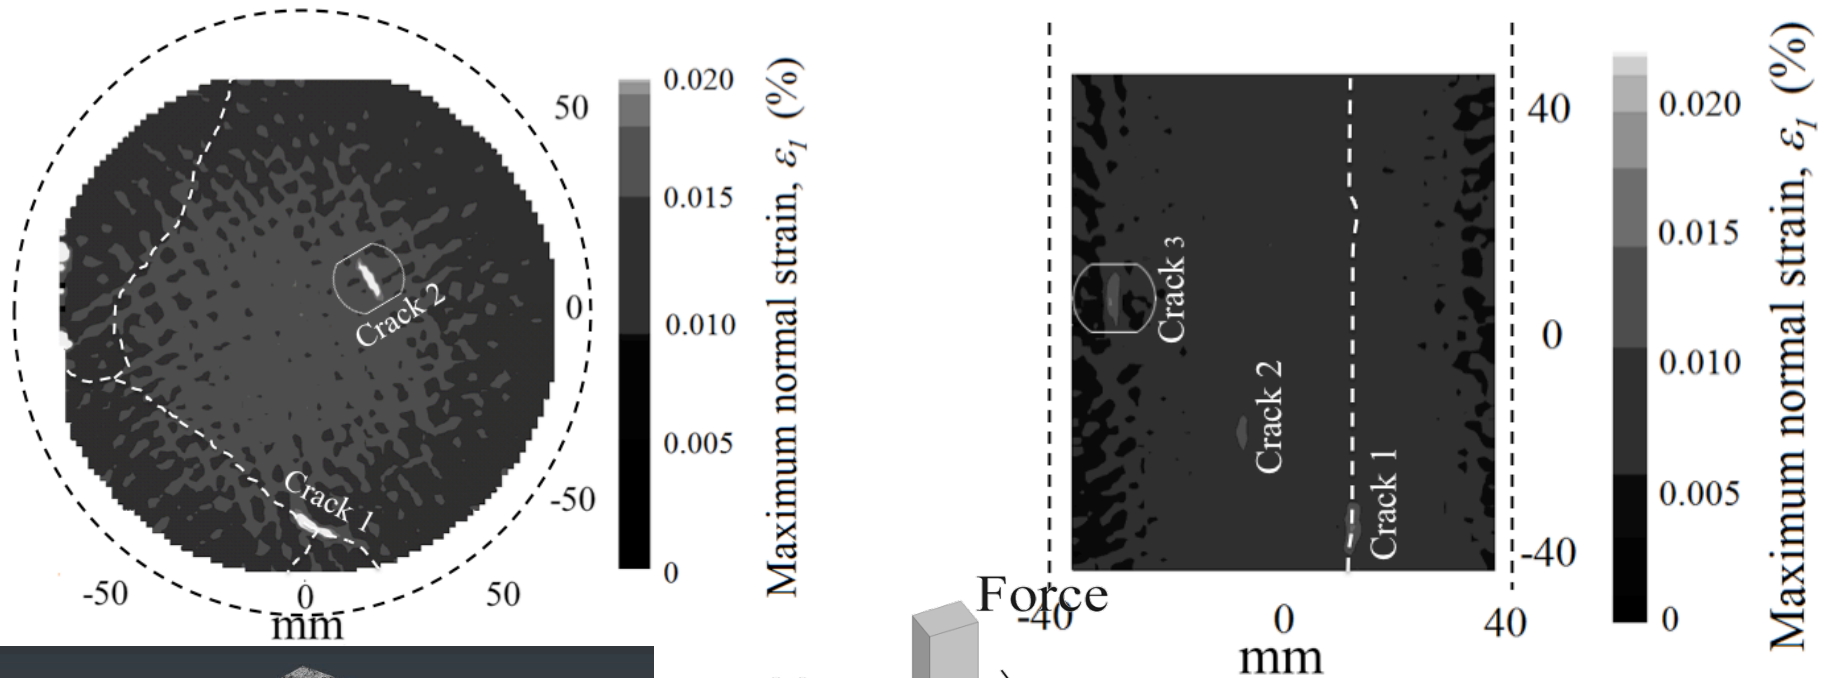
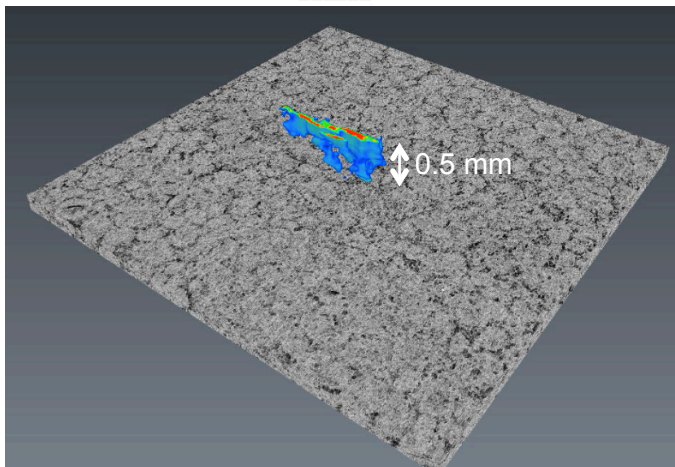
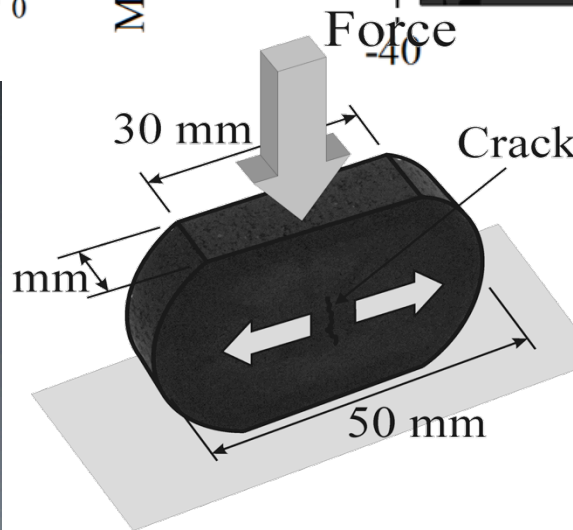
Defect depth  
~0.5 mm for both uniaxial  
and biaxial stress

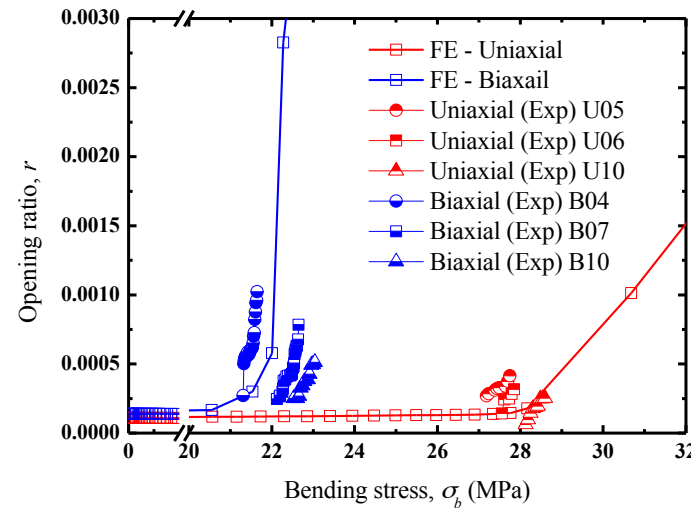
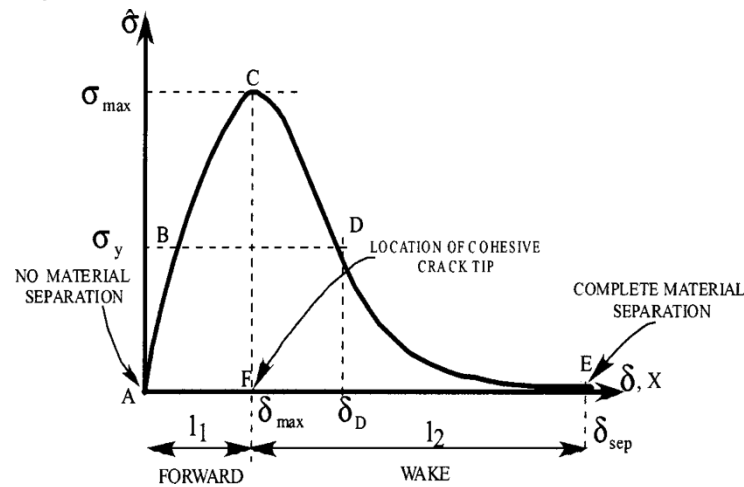
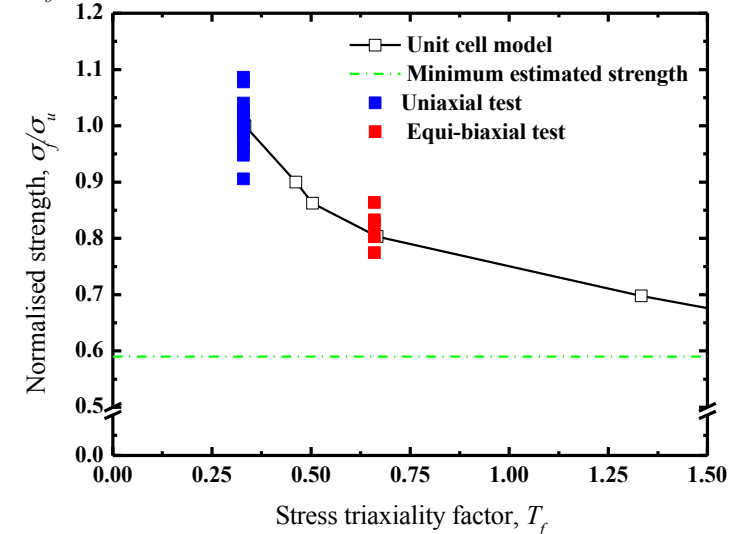
- Parameters calibrated using uniaxial test
- Effect of stress state on strength and opening ratio behaviour are in good agreement with experiment

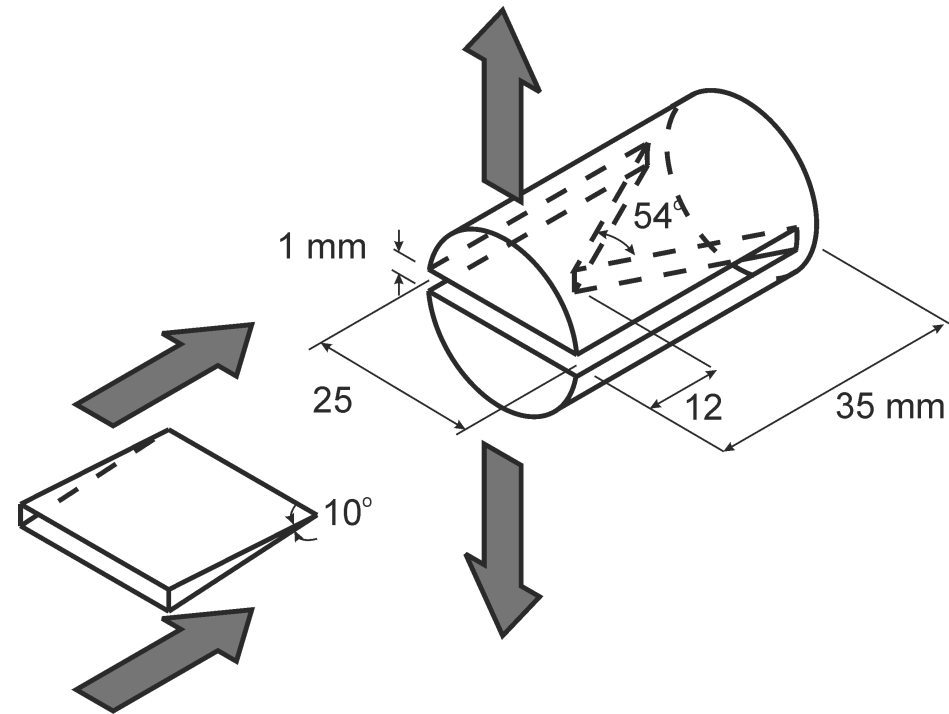
- Experiment objectives
  - Stable crack growth, observed in 3D
  - Specimen suitable for X-ray tomography
  - Measurement of crack opening and fracture process zone

- Short Chevron Notch Specimen

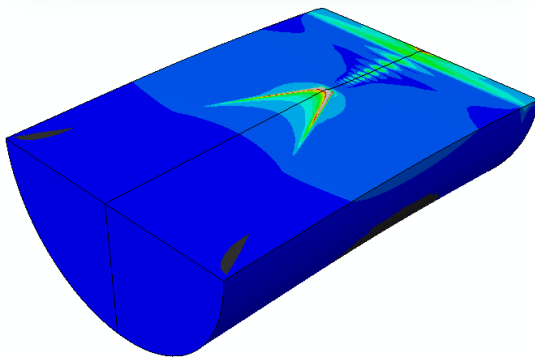
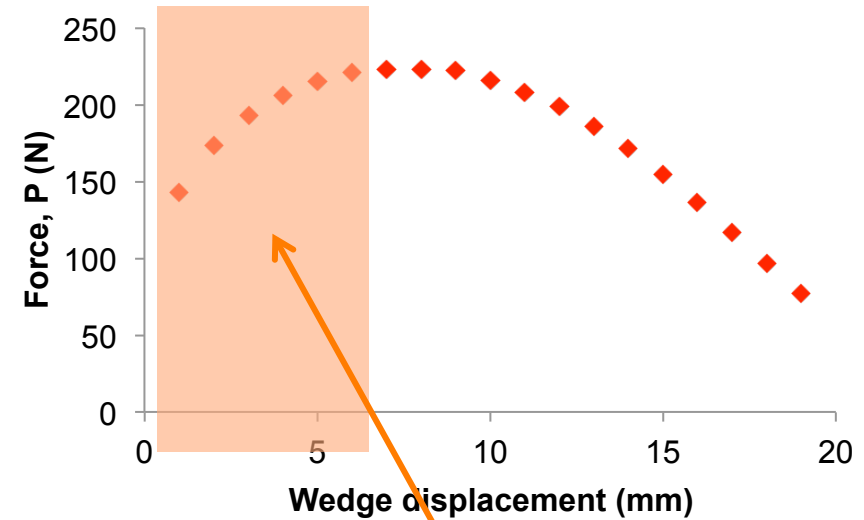
Stable crack growth region  
 $K=K_{1C}$

Finite element simulation of the fracture of chevron notch specimen

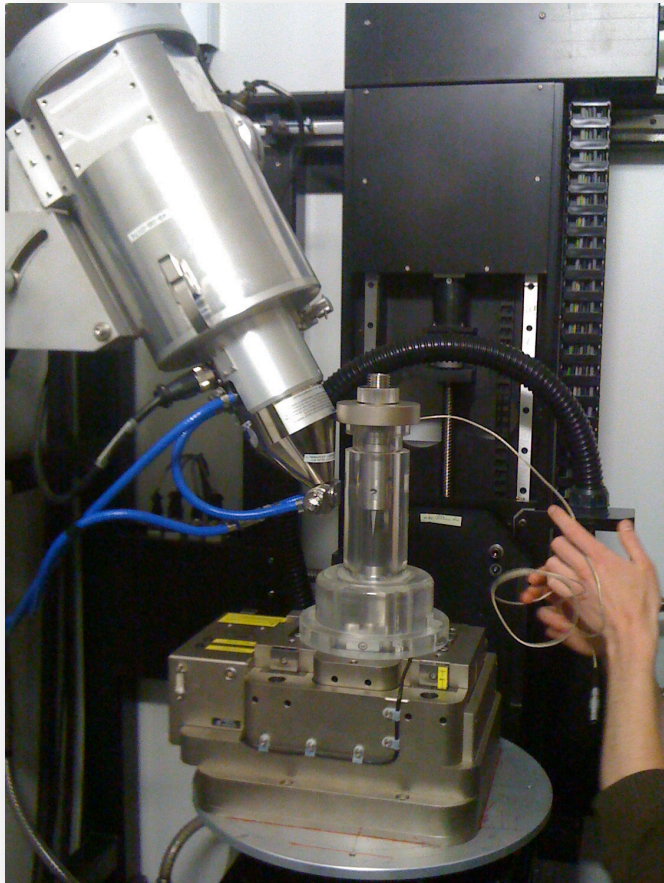
8  $\mu\text{m}$  resolution

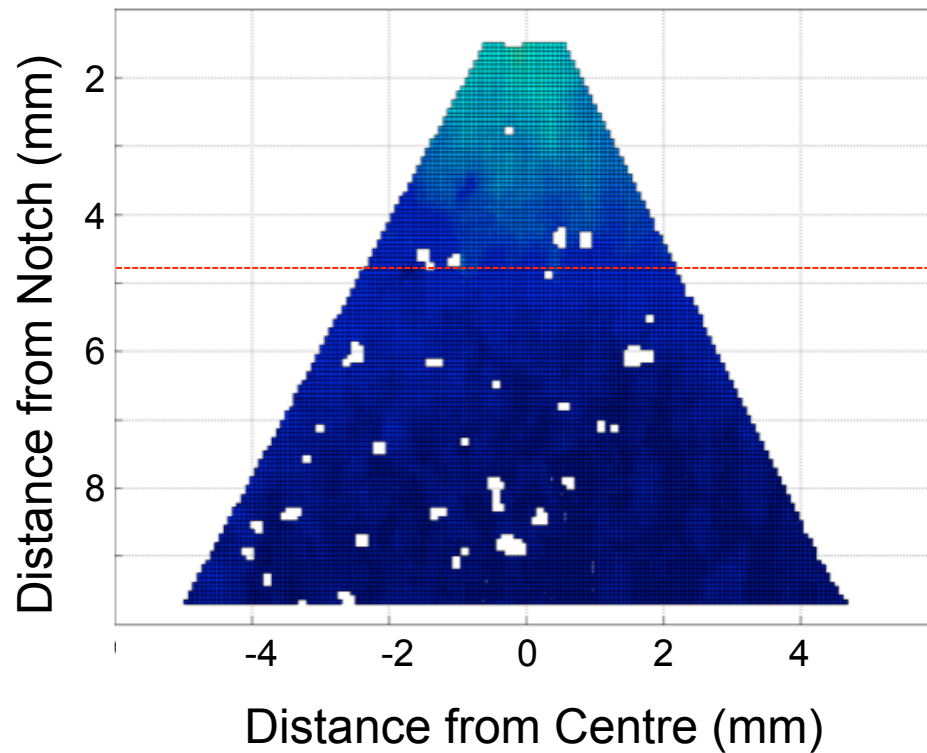
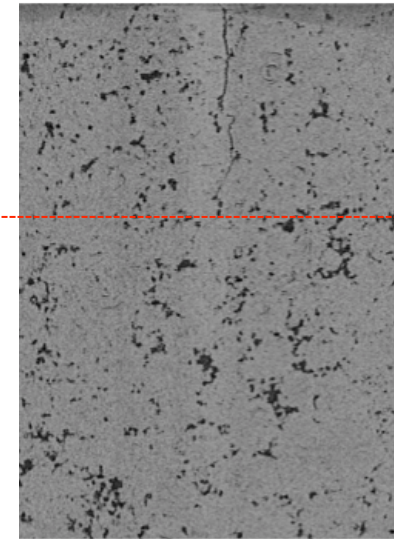
Load cycle 1

Central Slice

*White areas: DVC noise too high for automated measurement*

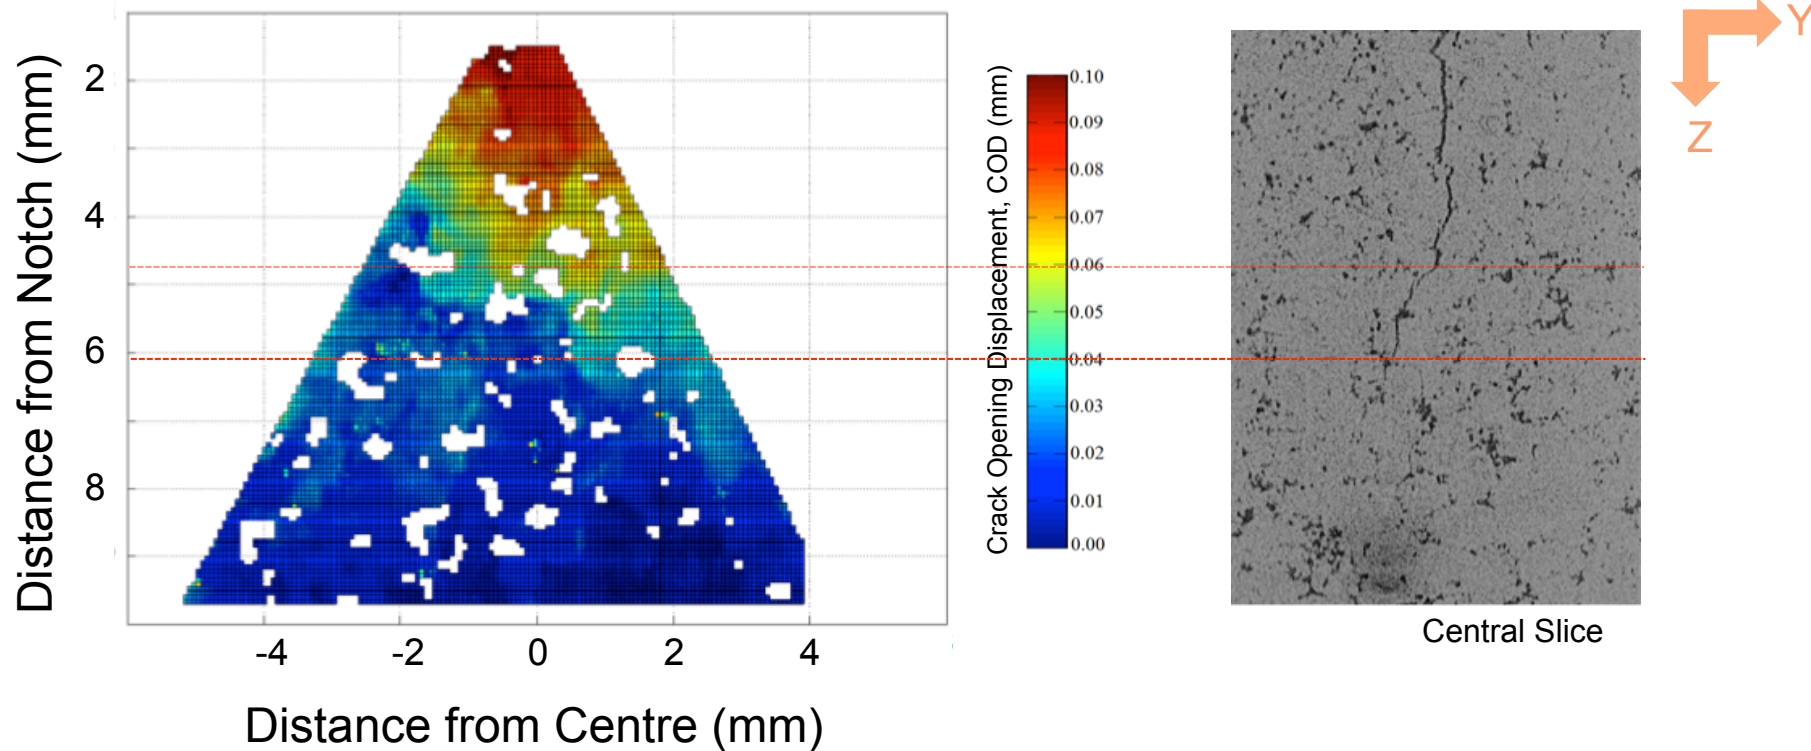
Load cycle 2

Crack opening in response to load can be mapped

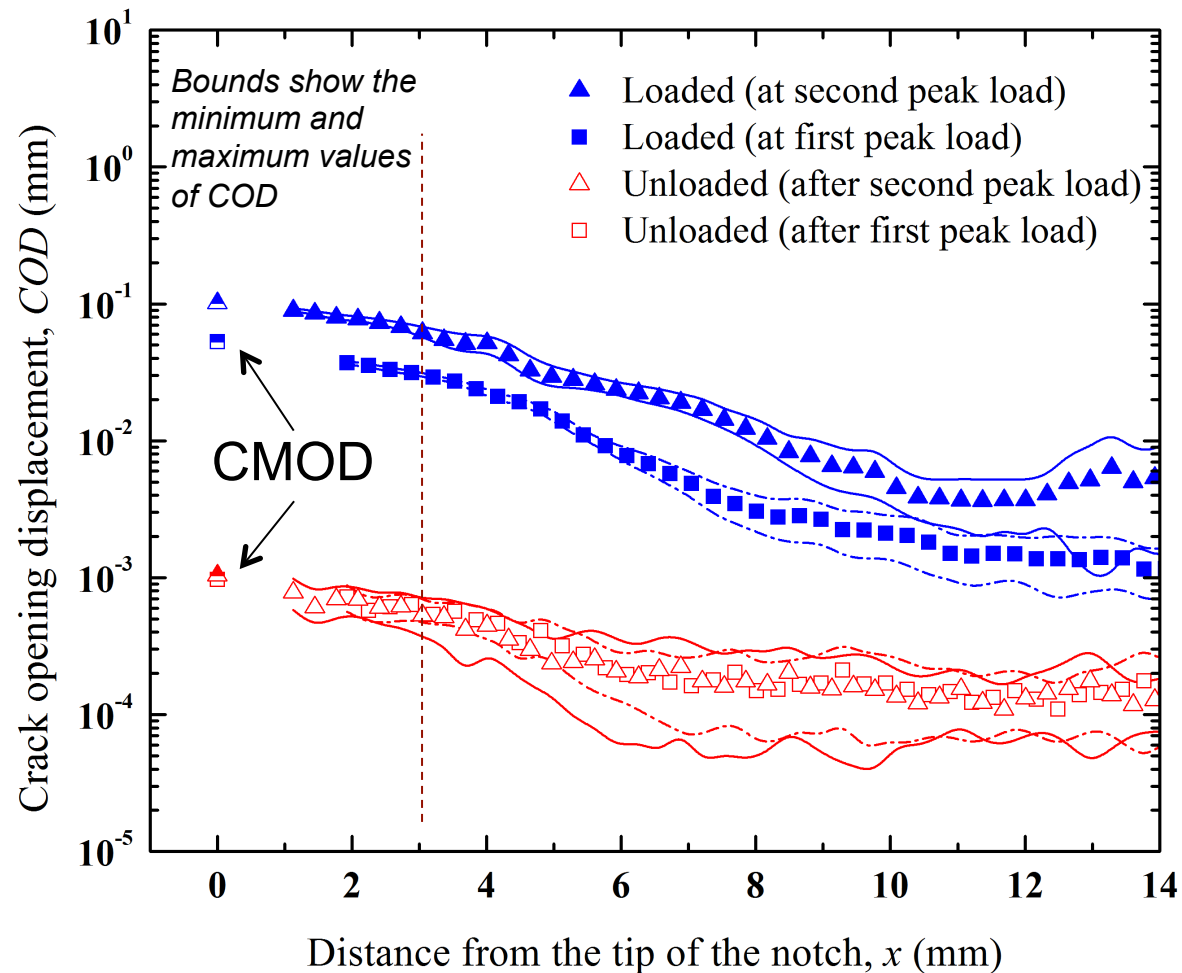
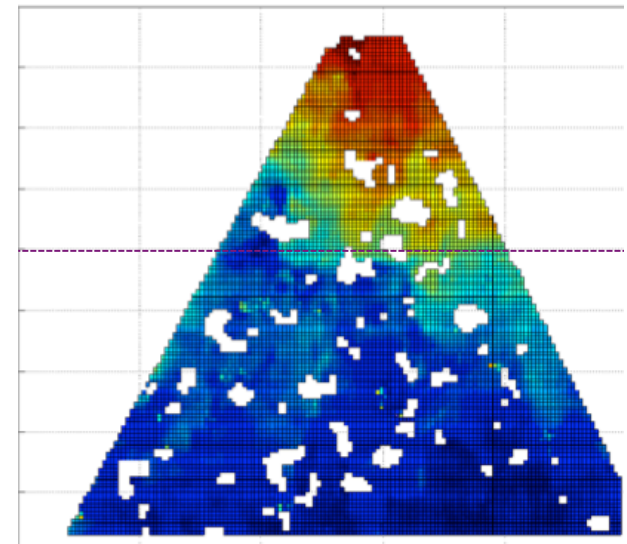
No residual displacements measurable when crack wake removed

CMOD – Crack Mouth Opening Displacement (extrapolated)

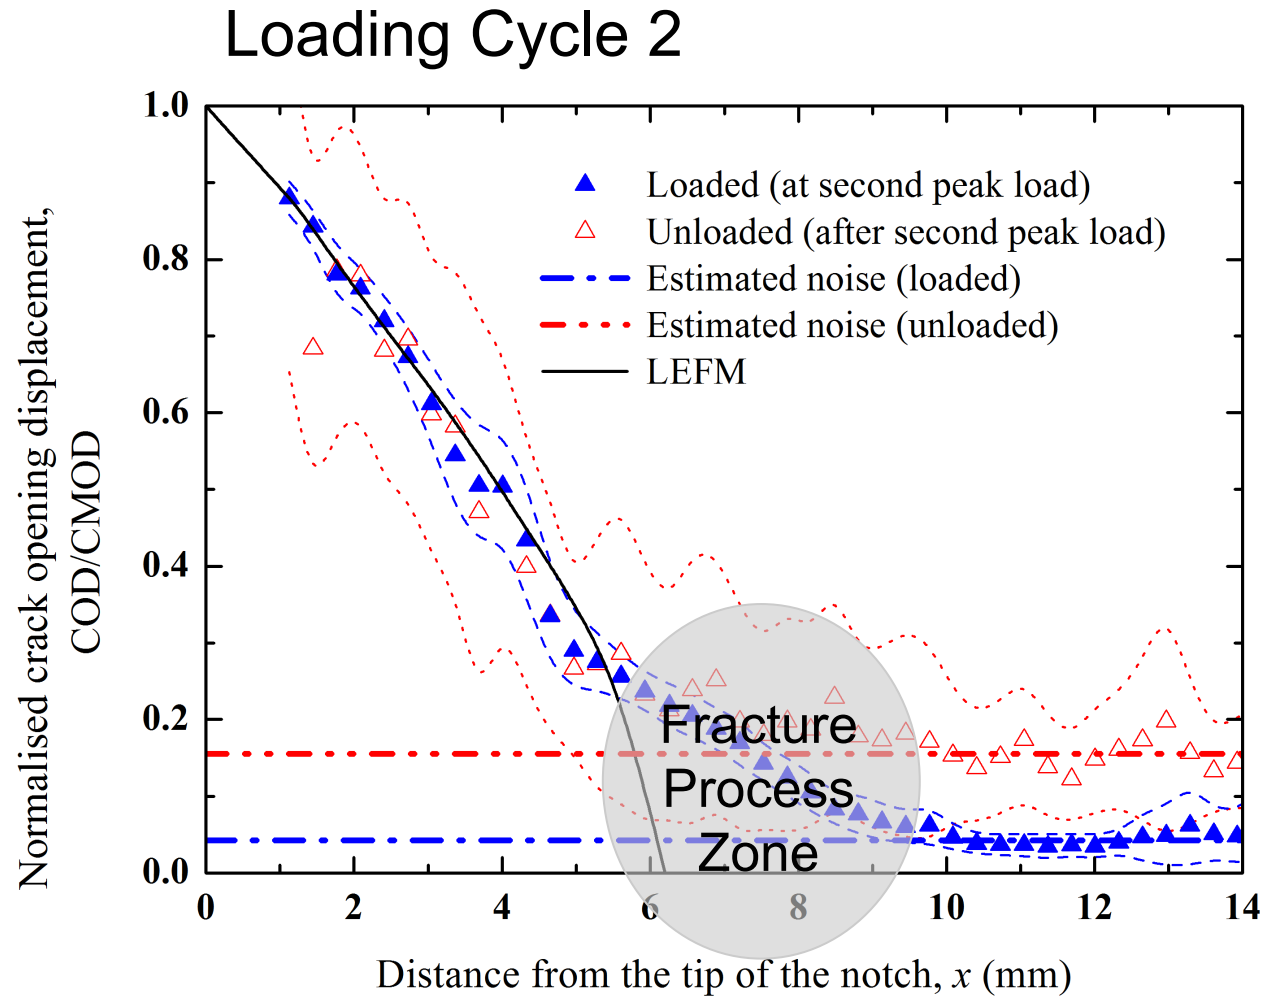
Elastic opening of loaded and unloaded crack is consistent with a nominal elastic crack tip

Significant displacements ahead of elastic crack tip when loaded
